Rural Municipality of
WEST RIVER

Building Condition Assessment - Roy Mutters Sports Field and Park

February 8, 2024

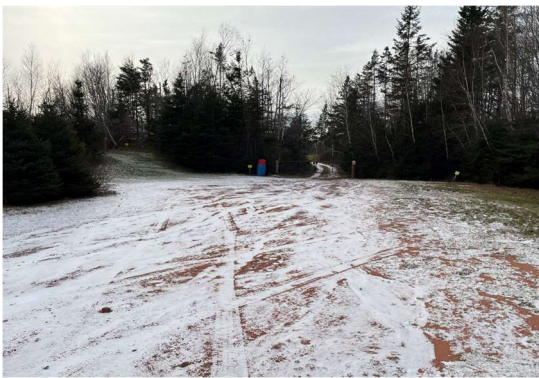
Figure 1 – Parking Lot

The parking lot was level and sloped to enable drainage.

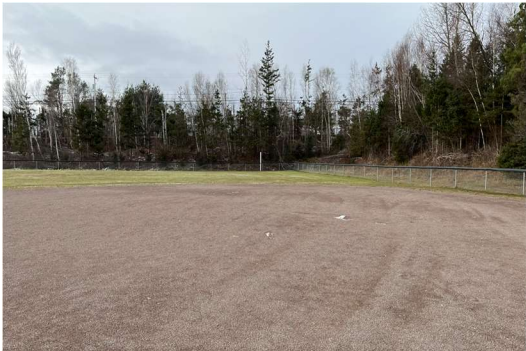
Figure 3 – Baseball infield

Project Description	Recommended Budget	Recommended Timing	Comments
Rake infield surface annually and dress with material and every other year.	\$3,000	2024	Baseball infield in good condition.

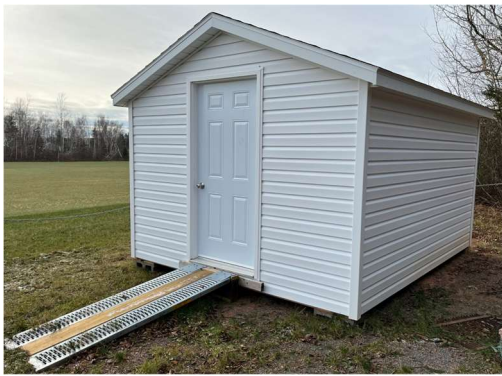
Figure 5 – Equipment Shed

The equipment shed is of wood construction with vinyl siding and asphalt singles. It is observed to be sitting level on concrete blocks. Significant expenditures related to the structure are not anticipated within the timeframe being considered in this report. We observed no signs of water penetration or damage. The shed appears to be in good condition

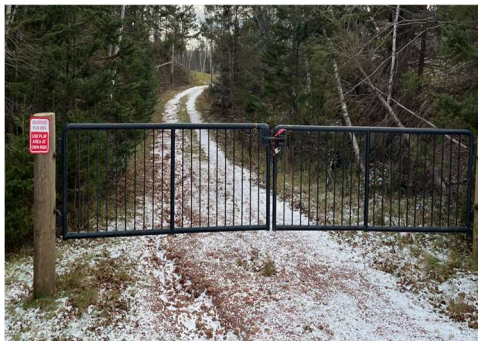
Figure 7 – Front Gate

The metal and wood posts at the entrance gate were observed to be level and structurally sound. Minor paint chipping was observed, it is recommended to paint the gate every five (5) years.

Project Description	Recommended Budget	Recommended Timing	Comments
Paint gate every five years.	\$2,500	2030	Gate entrance appears in good condition, operational
Paint metal goal posts every five years.	\$2,500	2029	Metal goal posts appear level and structure sound.

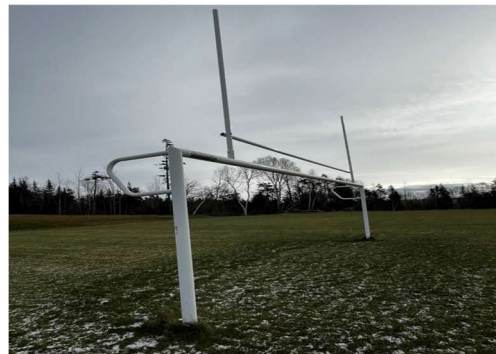
Figure 8 – Goal Post

The goal posts were observed to be level and structurally stable. It is recommended to inspect the structure annually to ensure that the in-ground mounts are secure, uprights are level, and that all connections are watertight showing no corrosion.

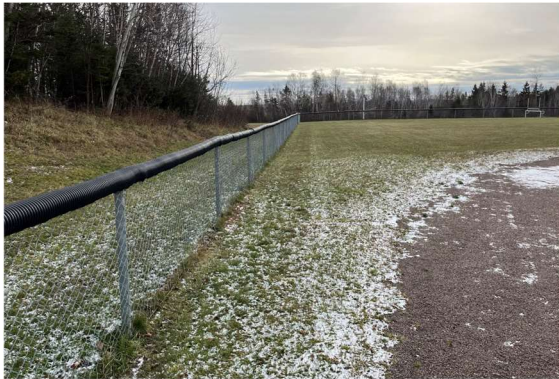
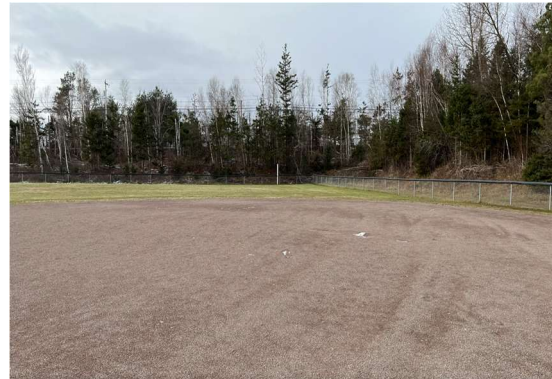
The field perimeter and baseball backstop chain link fencing were observed to be in good condition, showing no signs of rust. The wood and chain fence separating the parking area from open area was observed to be in good condition. The wood posts show no sign of decay. Significant expenditures related to the fencing are not anticipated within the timeframe being considered in this report.

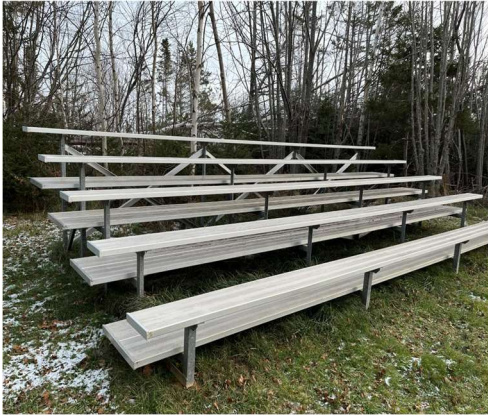
Figure 13 – Metal Bleachers

The park is equipped with several movable furnishings. The metal bleachers were observed to be in good condition. Significant expenditures related to bleachers is not anticipated within the timeframe being considered in this report.

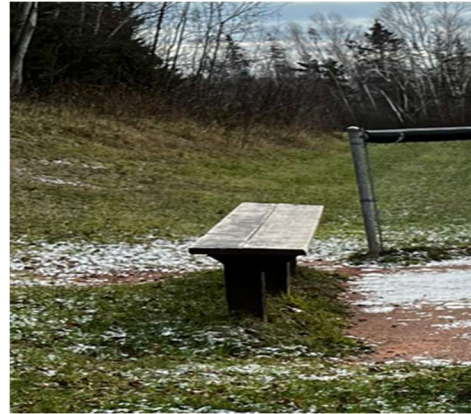
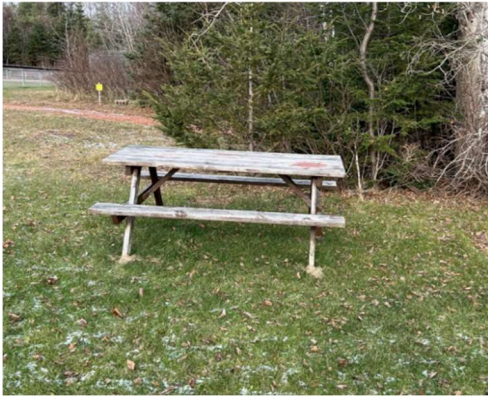
The wooden benches and picnic table are functioning. Signs of weathering were observed likely from year-round exposure to seasonal weather. It is recommended to conduct annual inspection of the wooden structures with seasonal repairs.

Project Description	Recommended Budget	Recommended Timing	Comments
Recommend annual inspection.	\$2500	2030	Wooden picnic tables & benches are in fair condition, beginning to show signs of weathering.
