Rural Municipality of
WEST RIVER

Building Condition Assessment - Roy Mutters Sports Field and Park

February 8, 2024

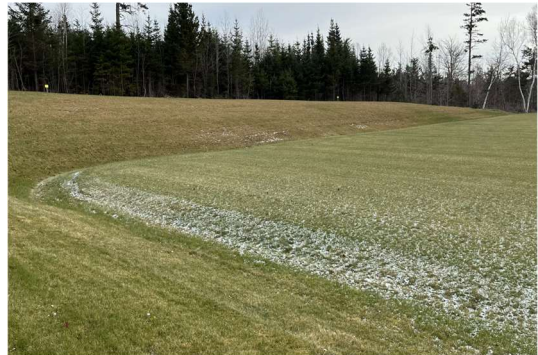
Figure 4 Field Drainage

There was no water present at the time of observation. The playing fields were well-maintained and in good condition.

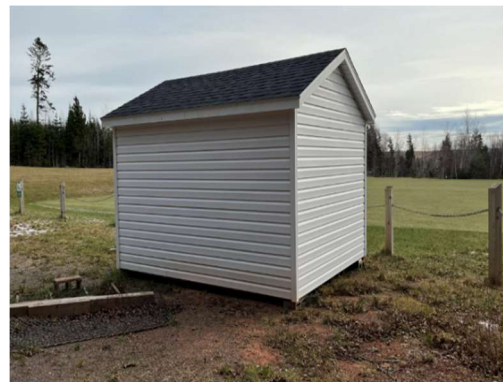
Figure 6 – Rear of Shed

The equipment shed is of wood construction with vinyl siding and asphalt singles. It is observed to be sitting level on concrete blocks. Significant expenditures related to the structure are not anticipated within the timeframe being considered in this report. We observed no signs of water penetration or damage. The shed appears to be in good condition
